# **Water quality measurements on Williams Lake and Colpitt Lake (Halifax, N.S.) Dec 7-13, 2015 with reference to possible impacts of road salt**

Report to Williams Lake Conservation Company (WLCC)

by David Patriquin

January 6, 2016

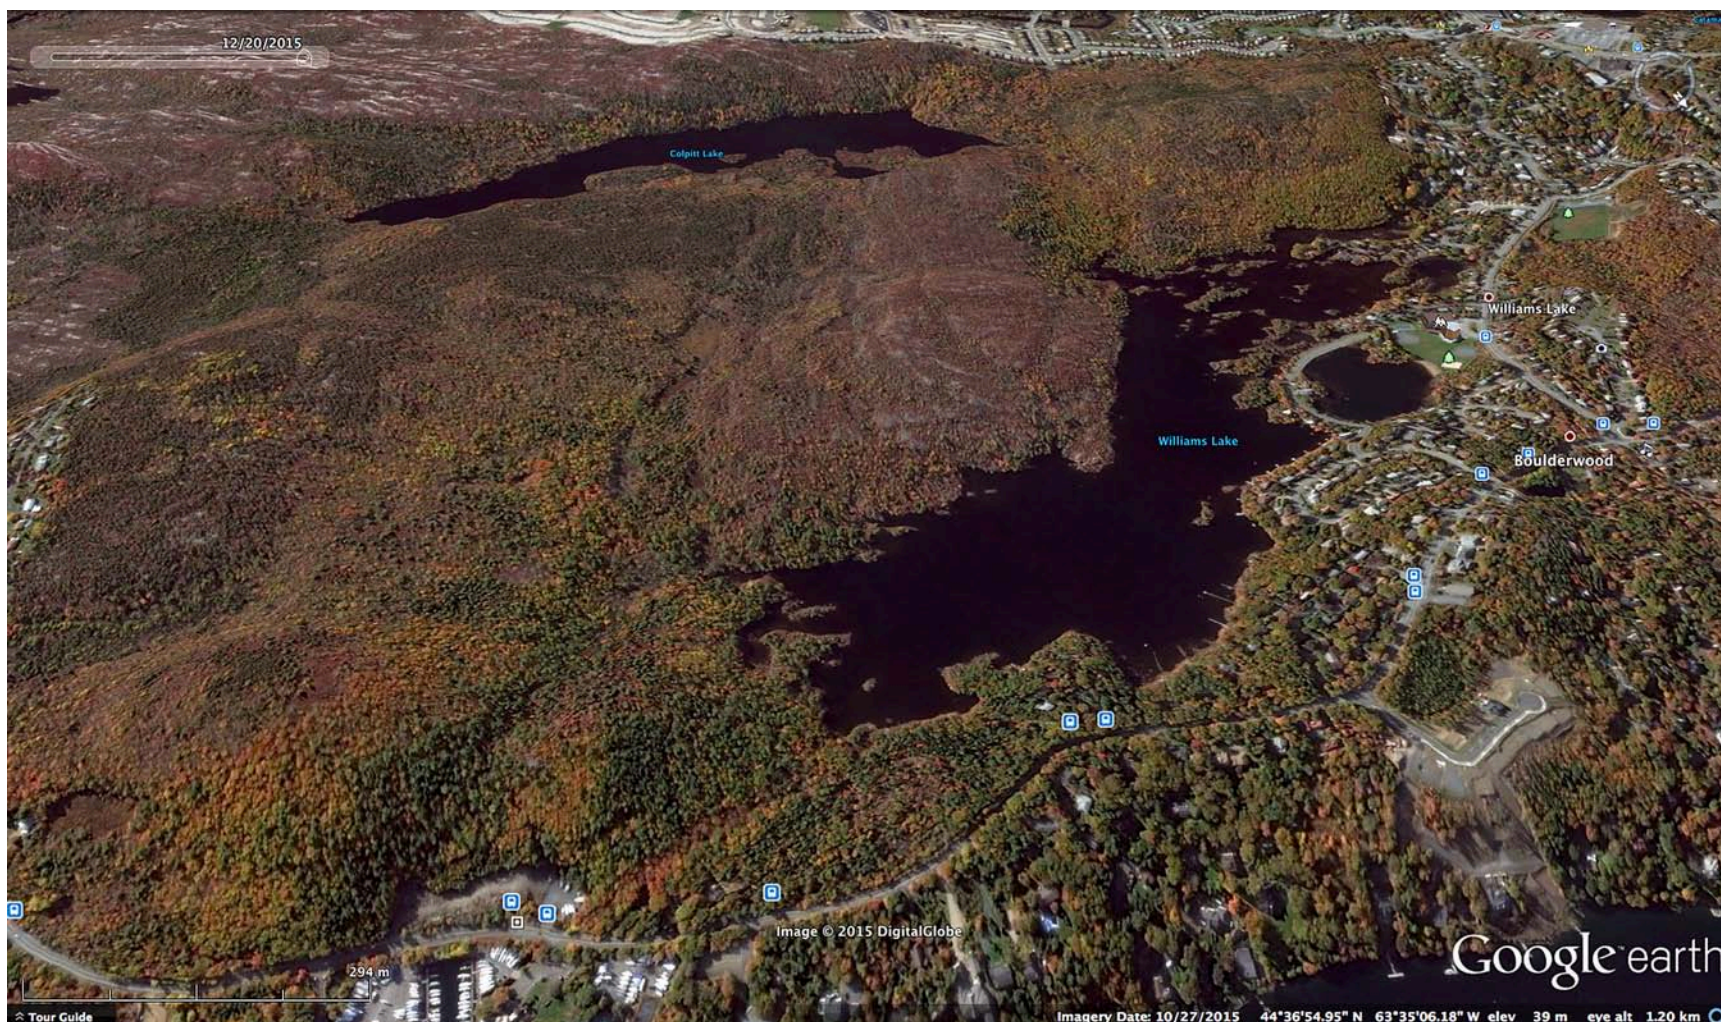
**Fig. 1. Google Earth image of the Williams lake watershed.**

The Williams Lake watershed is located on the mainland just off of peninsular Halifax. The watershed, approximately 487 ha, includes two lakes: Williams Lake (63 ha), bordered by developed land on about one-third of its shoreline, and Colpitt Lake (22 ha) which is entirely undeveloped (Fig. 1). Colpitt Lake is the headwater lake and drains into Williams Lake which in turn drains into the NW Arm. About three-quarters of the watershed is undeveloped, an undulating mosaic of wetlands, forests and barrens with a high degree of ecological integrity. Williams Lake is a popular swimming spot, and the lake hosts significant wildlife such a pair of nesting loons, and American eel. Over the years, residents have taken various actions to protect the water quality of the lake and as much as possible, the ecological integrity of the landscape.

Figure 1 (above) is a Google Earth Image of the Williams lake watershed.
